ONS 1EOC-20 Steam Generator Inspection Plans

ONS-1B TUBE SEVER OF TUBE 78-124

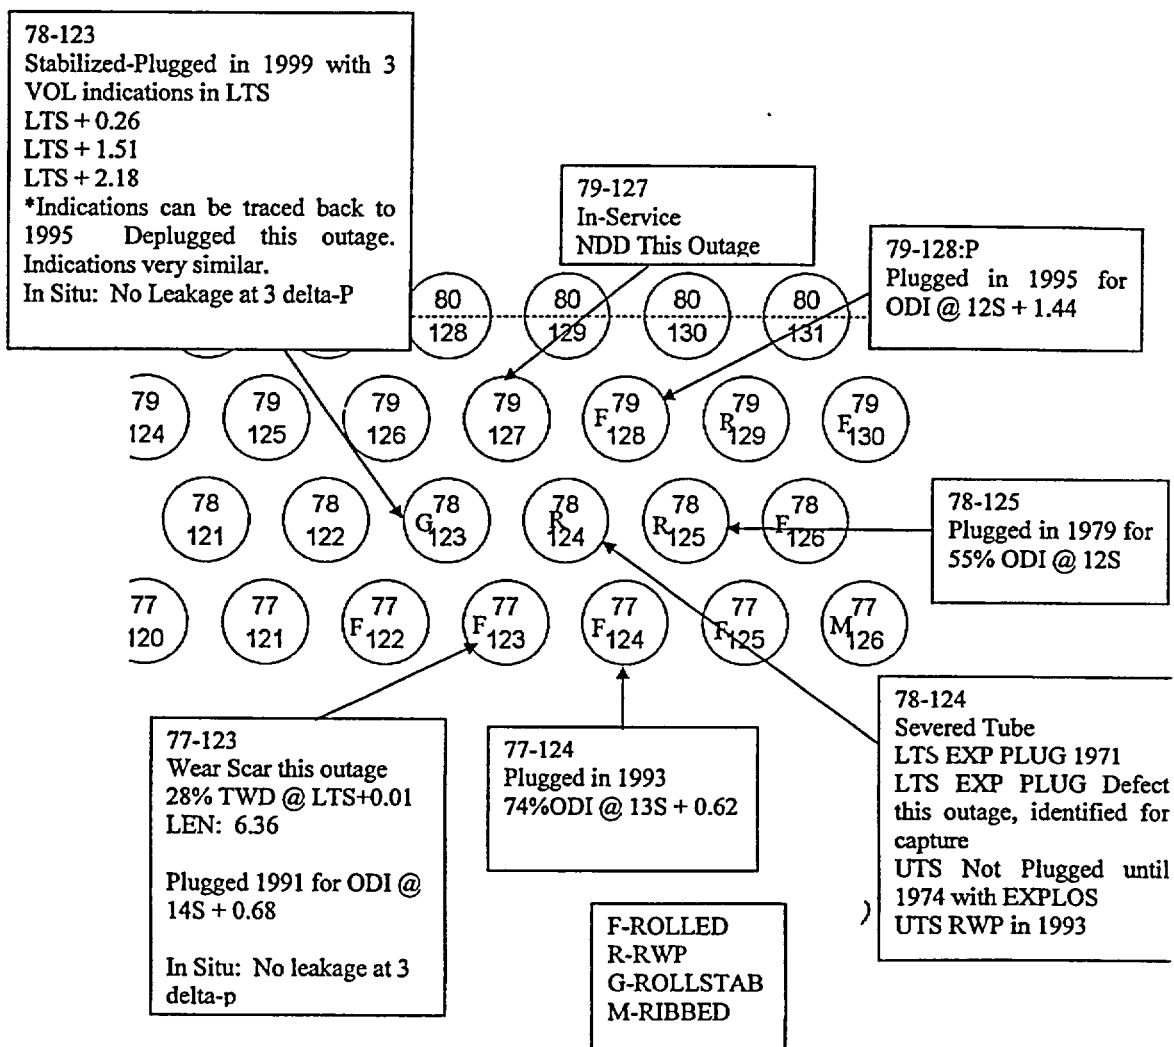
77-123: Plugged in 1991 for 38% ODI @ 14S + 0.68
 77-124: Plugged in 1993 for 74% ODI @ 13S + 0.62
 78-123: Plugged in 1999 for VOLs above LTS (See Note Above)
 78-124: Possible Sever (See Note Above)
 78-125: Plugged in 1979 for 55% ODI @ 12S
 79-127: Currently In-Service
 79-128: Plugged in 1995 for ODI @ 12S + 1.44
